Helena Thompson Museum, Workington

Feasibility Report

prepared by
URBED

on behalf of
Workington Heritage Group

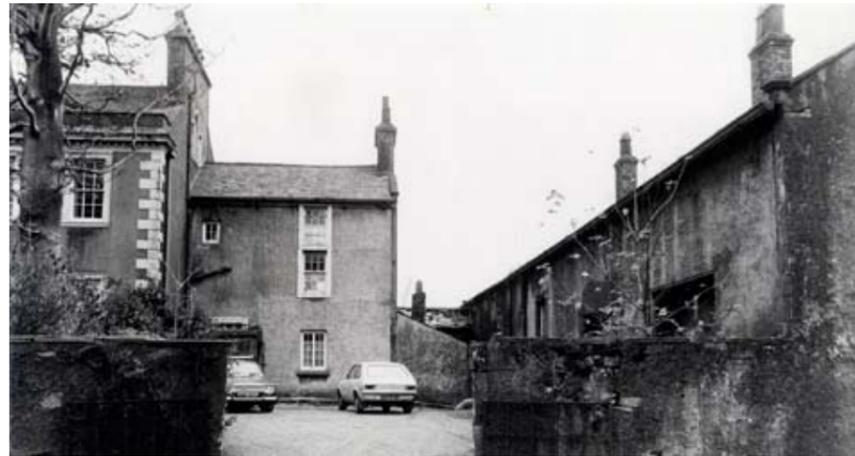
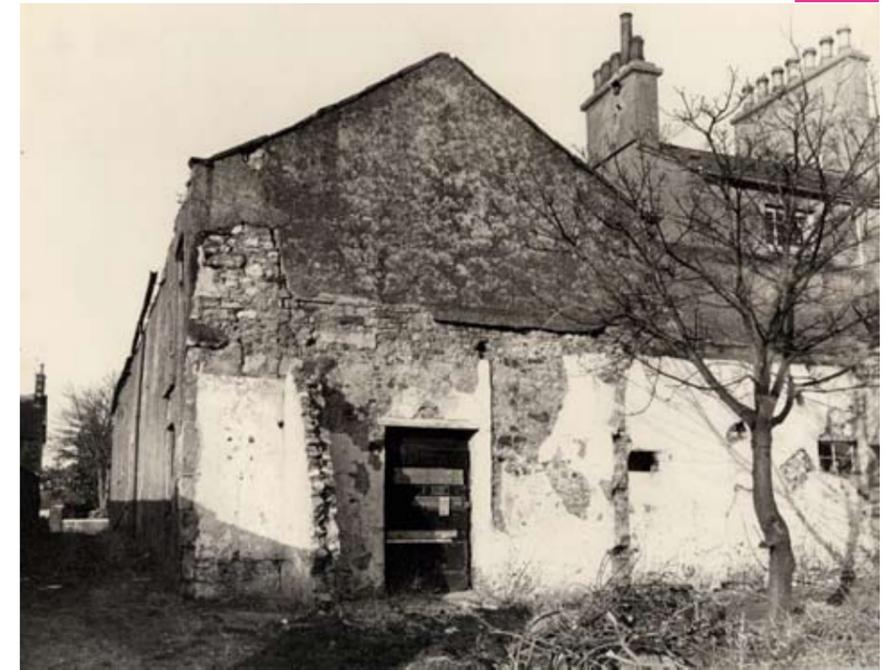
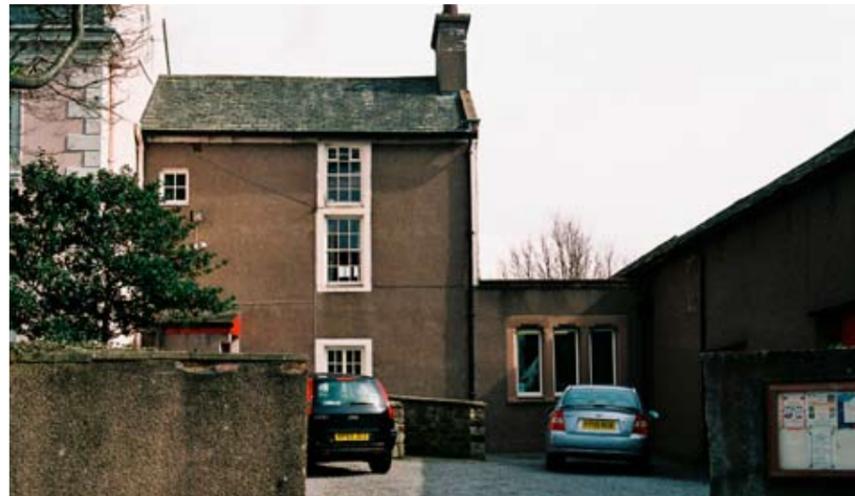
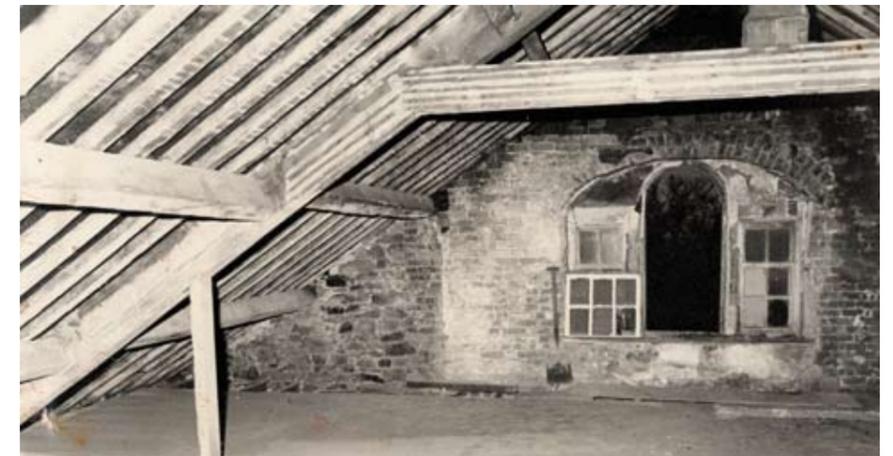
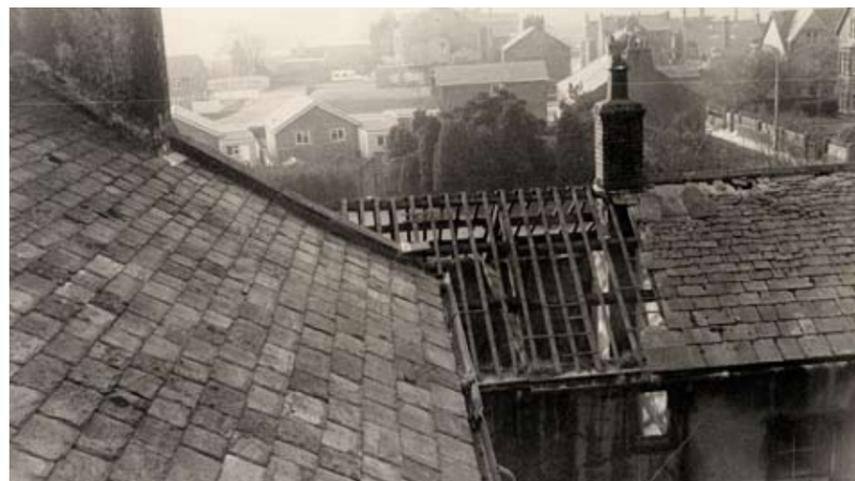
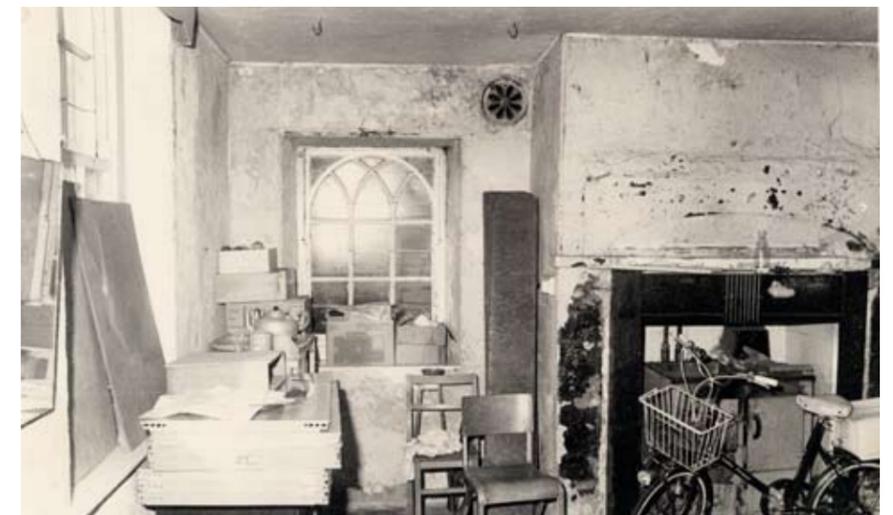
Clockwise from top right: Eastern elevation of stable block with evidence of demolished outbuildings and exposed sandstone walls; attic stripped out prior to refurbishment; 'Jubilee Room' in 1970s with original 18th century window; building roof-tops looking south (1970s); front elevation of annex today; front elevation of annex prior to construction of link building.

Further substantial work was carried out in the early/ mid 1980s. This had a significant impact on the appearance and layout of the building. This was the last major work done on the building and is still very much in evidence. The link building between the annex and the stable block was constructed. This is a single storey, flat roofed building, quite unsympathetic to the surrounding 18th century buildings. It contains a refreshment area, small kitchen and WCs. The window to the front elevation has a reinforced concrete surround which is in poor repair. It attempts to match the sandstone surrounds of the original windows, though in a noticeably different style.

In addition to the new link building, works were also carried out to the stable block and annex building. The stable block was renovated to its current state, with the construction of a new ramp and steps, new external doors and complete internal re-plaster. Original openings, mostly on the south side of the building, were filled in, the roof was repaired and partly insulated.

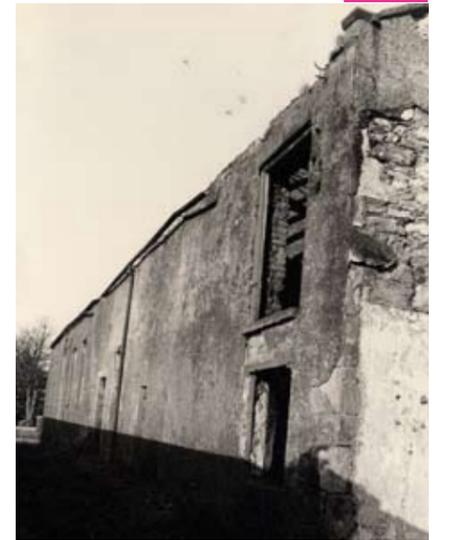
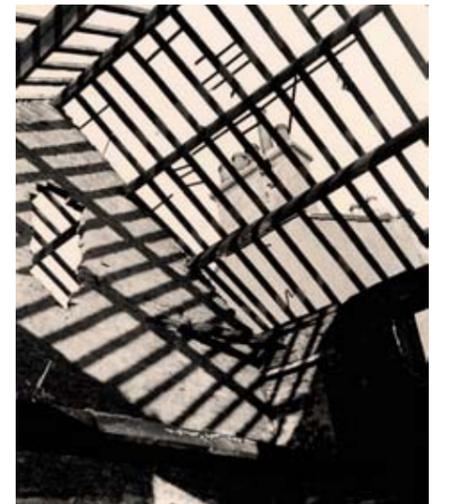
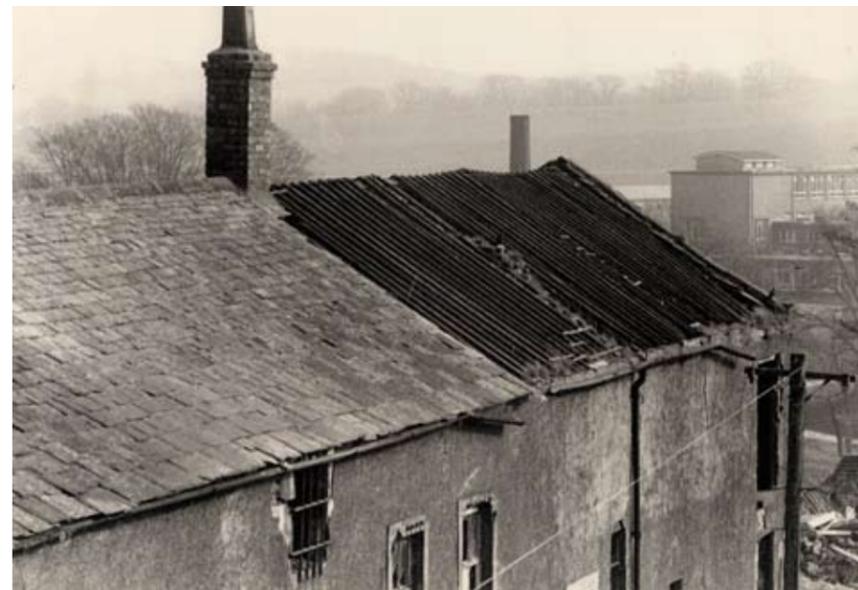
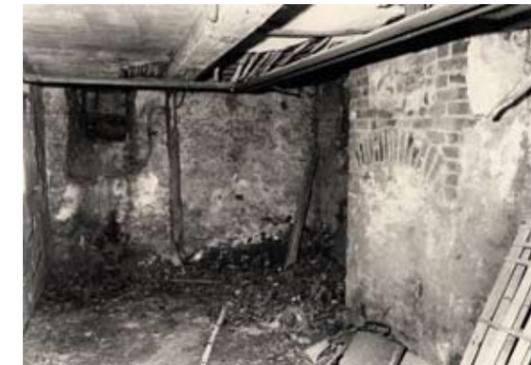
Clockwise from top left: Plan prepared by Allerdale Borough Council, dated 1978, showing the previous configuration of the plan of the stable block and outhouses; south elevation of stable block, prior to original windows being blocked up; view of interior of stable block and derelict roof in 1970s; cellars prior to clear-out and restoration of timbers stable building roof-top and south elevation looking east (1970s).

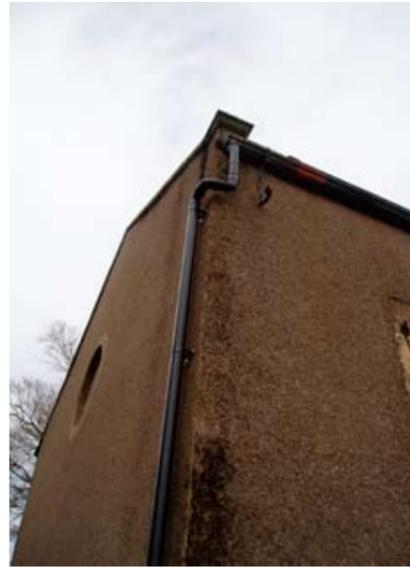
Above: uPVC rainwater pipe on stable block with inappropriate 'wet-dash' concrete render.

- The removal of the inappropriate concrete render on the annex building and coach-house. This render may be causing damage to the building fabric. It is vapour impermeable, so any water vapour travelling from inside to out is trapped beneath the render, where it is liable to condense and cause damp problems. This render should be replaced with a breathable lime-based render. Specialist advice to be sought on this.

- The replacement of any uPVC rainwater goods with cast iron or cast aluminium materials with profiles to match the original. This is both more appropriate for a listed building and will reduce long-term maintenance costs: cast iron and aluminium have life spans in excess of 30 years. uPVC in this situation normally has to be replaced every 10-15 years.

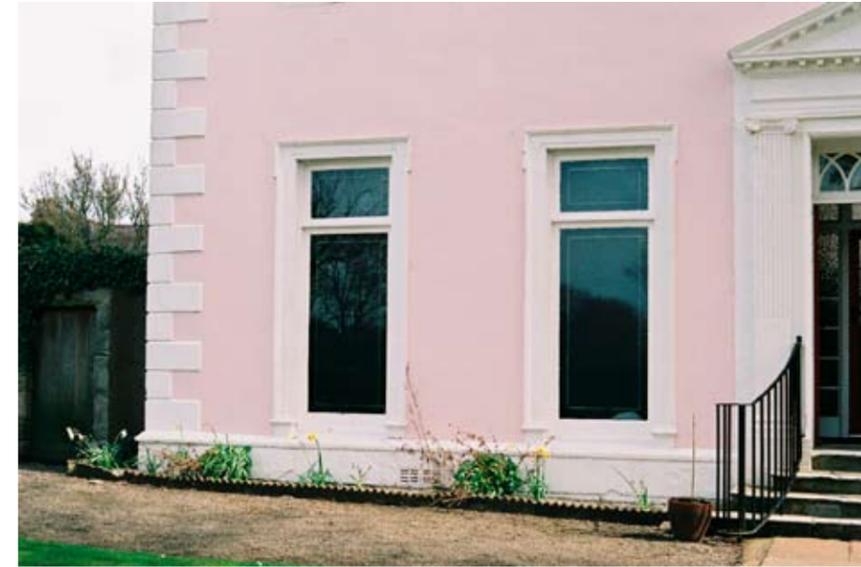
Above Right: Windows to costume gallery.

Costume Gallery - It is intended that the current inflexible display cabinets these should be replaced so that this room could also be used for meetings and functions, as well as display. The windows to the front elevation of the building should be opened up to admit controlled daylight.

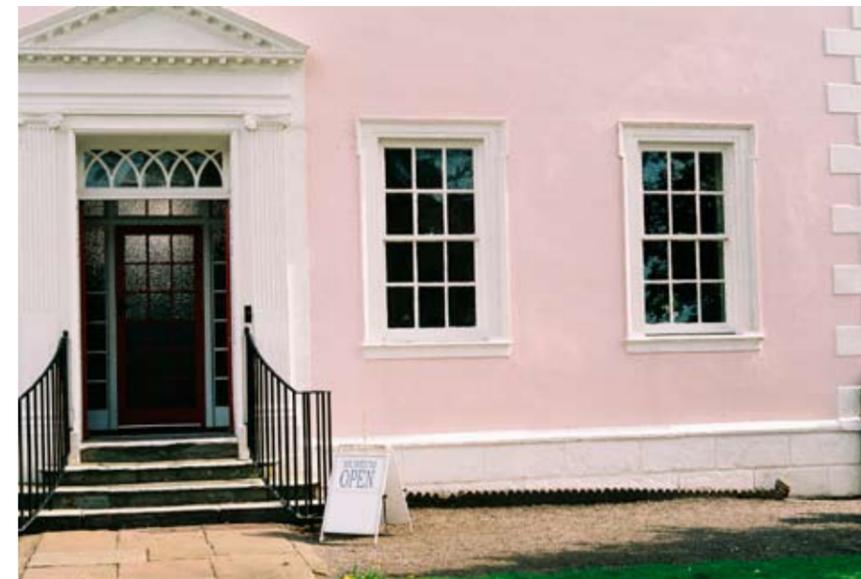
Right: Original Georgian windows in front elevation.

- The repair and refurbishment of original cast-iron rainwater goods.
- The refurbishment and draught-proofing of original timber windows.
- Investigate further the possible reinstatement of Georgian windows to the Costume Gallery front elevation, to restore the original proportions of this elevation - under advice from conservation specialist and following further historical research.

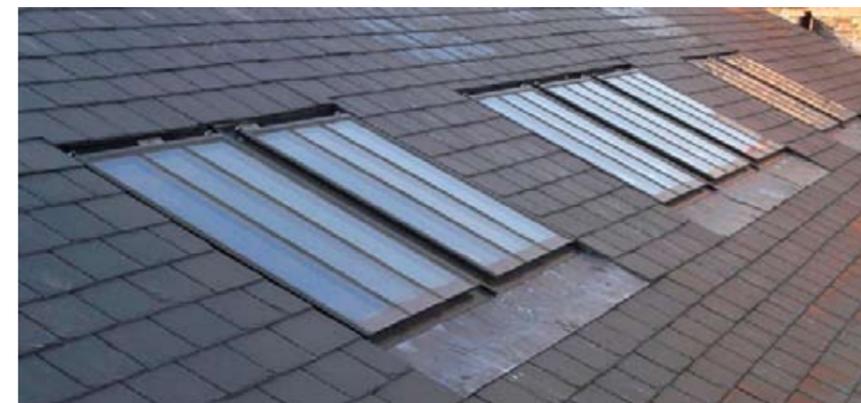
Below Right: example of roof-lights in a conservation setting

example of roof-lights in a conservation context

To this end we recommend the introduction of roof-lights in the north-facing roof of the stable block - which currently has no day-lighting at all. These could have the dual function of improving the ventilation and airflow in this space. This will improve the internal environment whilst also reducing the need and therefore the costs of artificial lighting. These roof lights should be fitted with adjustable blinds, to maintain flexibility of use in this area. It may also be possible to re-open some of the original openings elsewhere in the stable block, and glaze some of the existing door openings to admit more light.
